UNITED STATES ENVIRONMENTAL PROTECTION AGENCY REGION II

SUBJECT: Removal Site Evaluation for the Diamond Head Oil Refinery Site, Kearny, Hudson County,

New Jersey

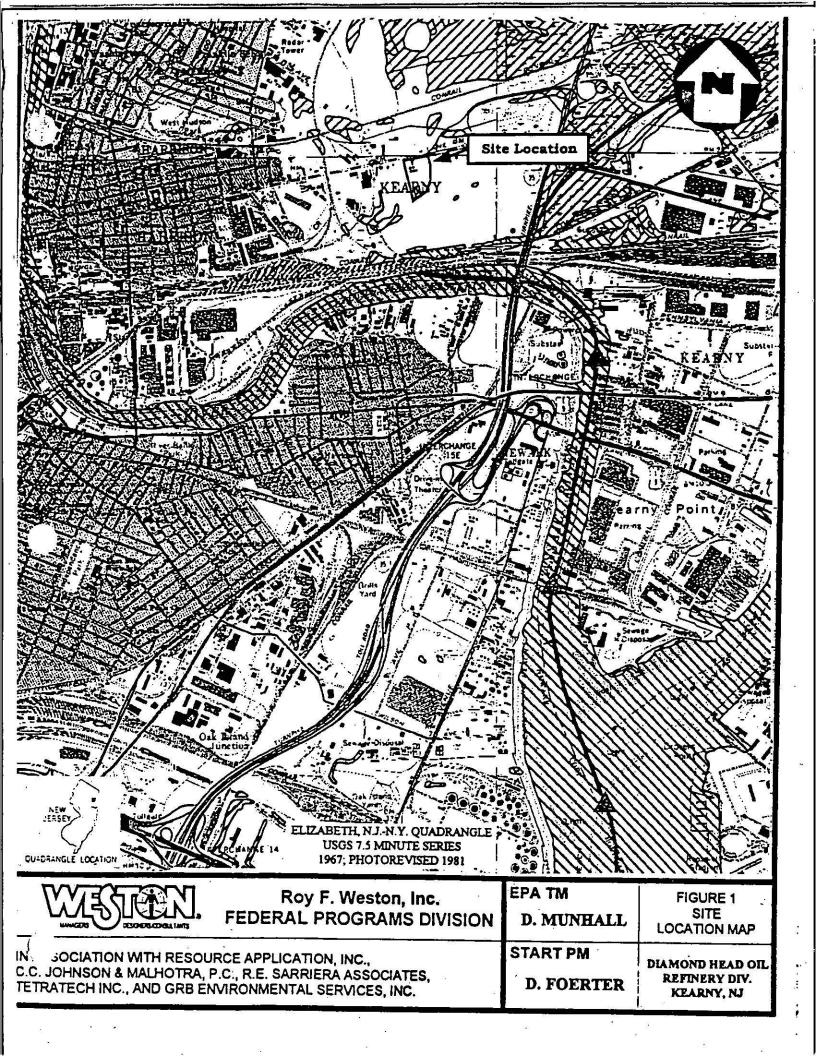
The Site is located at 1401 Harrison Avenue, in Kearny, Hudson County, New Jersey (see Figure 1). Currently the Site is inactive and consists of approximately 15 acres of undeveloped land that is bordered by Harrison Avenue to the north, the entrance ramp to Interstate 280 to the east, a drainage channel bordering Interstate 280 to the south, and the Campbell Foundry to the west. A Public Service Electric and Gas (PSE&G) right-of-way runs the length of the Site near the western boundary. The area around the Site, situated just west of Exit 15W of the New Jersey Turnpike, is industrial. There are no residential areas in the vicinity of the Site. Harrison Avenue (aka Newark-Jersey City Turnpike) is used heavily by trucks and commercial vehicles.

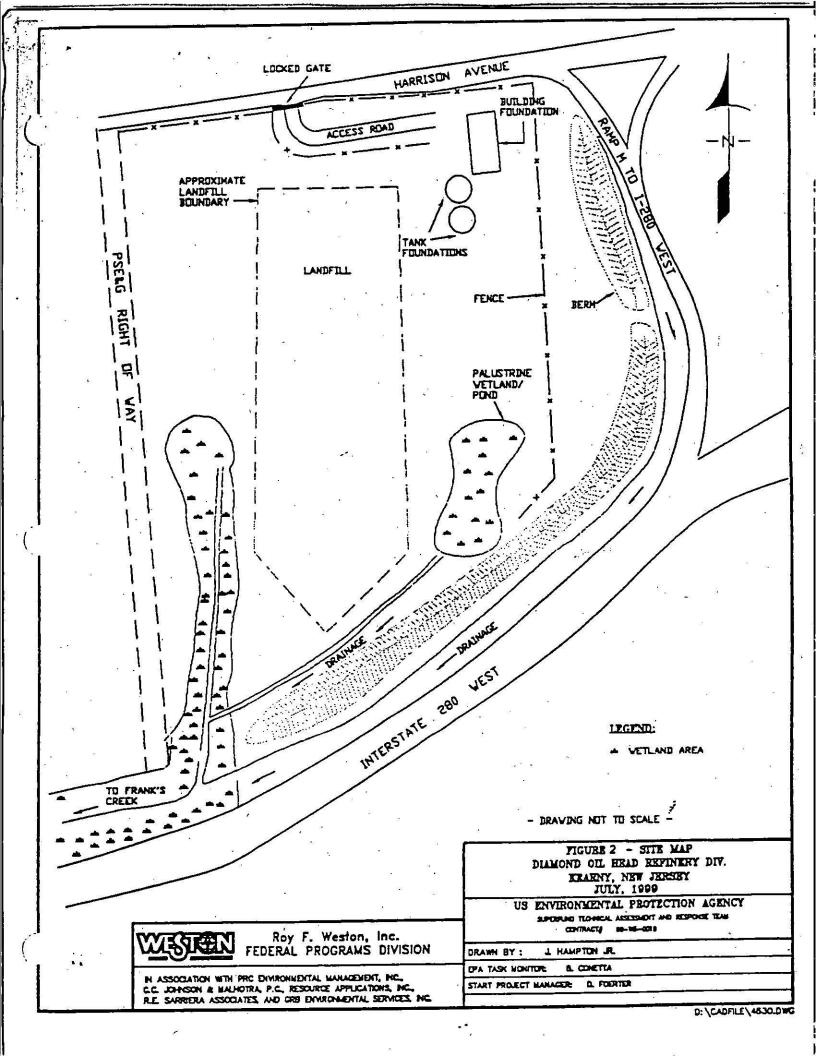
Currently, all that remains at the Site is a former construction debris landfill, foundations of former tanks and buildings, and a paved access road from Harrison Avenue (see Figure 2). The landfill and oil lagoon are approximately seven and five acres in size, respectively. The Site is flat over the eastern section where the former reprocessing area and lagoon were located. The topography rises approximately 15 feet towards the west to where the landfill is located. The western portion of the Site is also relatively flat.
